Pali Consulting

MEMORANDUM

Limited Geotechnical Evaluation
North Bank Working Landscapes Project
Coos County, Oregon
Pali Consulting Project #014-18-001

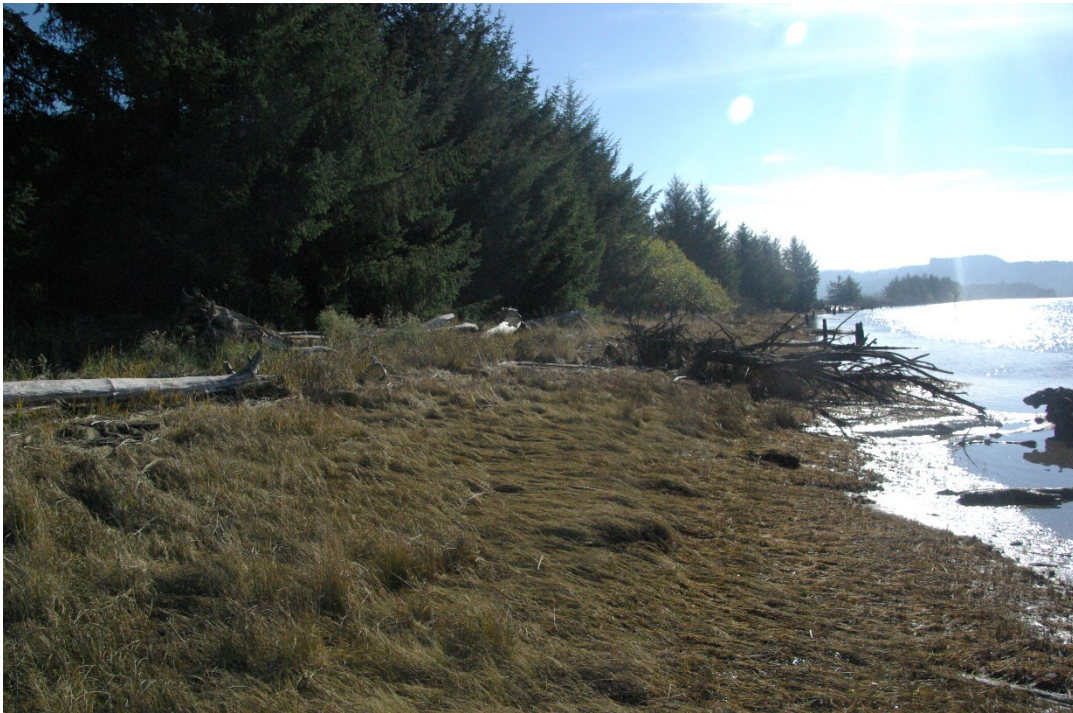
Photo B-1

Station	Conditions/Notes	Soil Exposed / Laboratory Results	Face Height	Photo
T-1	North end of site.	No soil exposed.	0	B-1
T-2	Area of erosion/vertical face, trees above, rip rap in front.		2 – 3'	
T-3	Small piling in front of embankment; continues to east. Eroded behind piling.		3 - 4'	B-2
T-4	Severe erosion with increasing severity from T-2.		5'	
T-5	Undermined tree.	Fine sandy silt (ML), non-plastic.	5'	
T-6	Soil samples collected at 4' and 1' from top of levee.	Elastic silt (MH) over silt with fine sand (ML), low plasticity. Thin layer of gravel at base. Lab tests: 1': #200 = 74%, LL = 53, PI = 22 (MH) 4': #200 = 71%, LL = 42 PI = 14 (ML)	5'	B-3
T-7	Timber piles in front for erosion protection. Many insect holes along face. Height of face decreases to south through this section. Round and angular rip rap at waterline.	Fine sandy silt (ML), low plasticity.	3 - 5'	B-4
T-8	Trees absent; face of levee unvegetated. 4H:1V slope except 3H:1V eroded slope at high water line. N end of repaired area. Starts at	Fine sandy silt (ML), low plasticity.	0	B-5

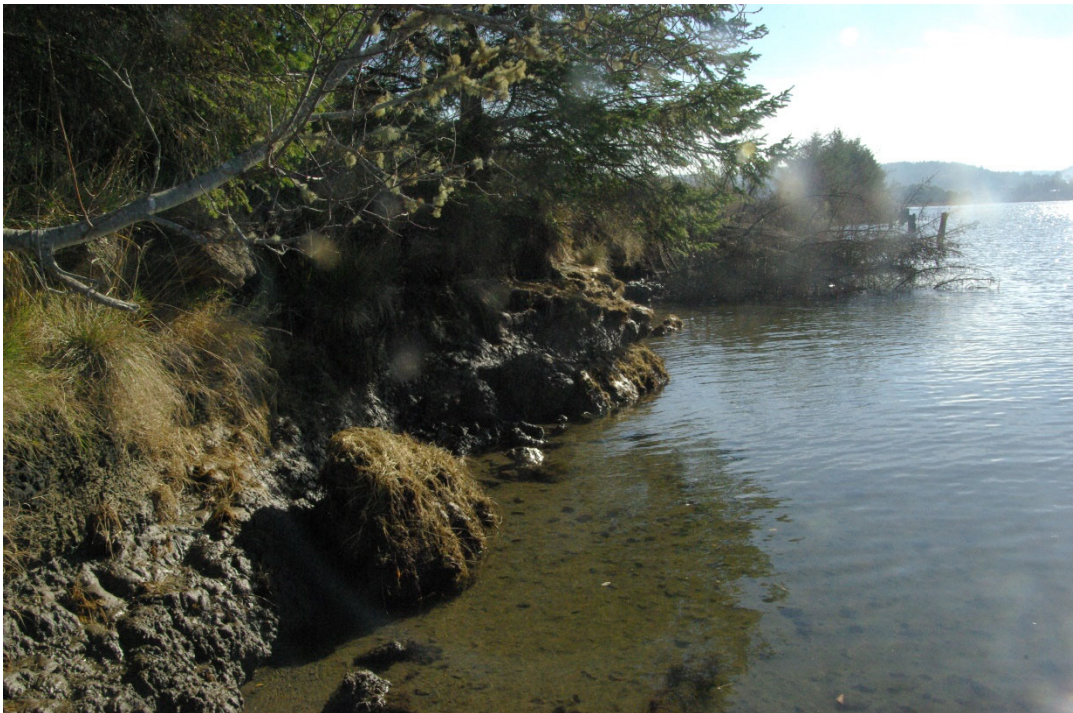
Photo B-6

Station	Conditions/Notes	Soil Exposed / Laboratory Results	Face Height	Photo
	end of piling and continues 100 to 200' south.			
T-9	Rip rap on toe of levee at south end of repair. Face transitions to vertical, evidence of fallen "blocks" of soil.		5'	B-6
T-10	Borrow area for repair or low area landside of levee. Pile revetment along front of embankment here.	Clayey silt ~ 2' below adjacent surface with extensive desiccation cracking. Lab Results: 2': #200 = 85%, LL = 100 PI = 50 (MH)	NA	B-7
T-11	From T-10 to T-11 trees either toppled by erosion or cut off and undermined. Vertical face increases from north to south to 6' high at T-11.		6'	
T-12		Silty fine sand (SM) to sandy silt (ML) in top 3', grading to ML/MH at base.	3 - 5'	
T-13	Variable erosion and soils exposed are similar to others observed.		3 - 6'	B-8
T-14		3' fill over 3' native. Native is expansive based on desiccation cracks and field plasticity. Fill is silty fine sand with occasional boulders on surface and in outcrop.	6'	B-9

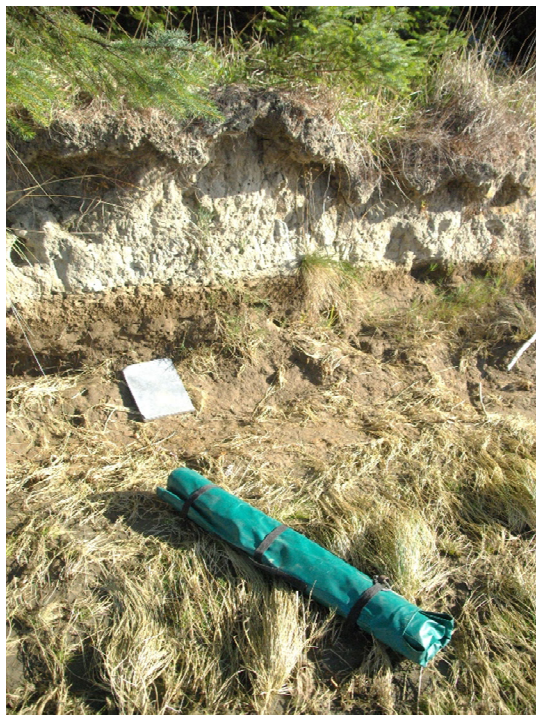
Photo B-10

T-15	Similar erosion/configuration of lower bank on west side of river (see Photo A-12).	3' sandy silt fill over 3' silty clay. Less desiccation cracking. Interpret lower soil as native. Lab Results: 2': #200 = 62%, LL = 32, PI = 5 (ML) 4': #200 = 79%, LL = 42 PI = 35 (CL-ML)		B-10 B-11 (west shore)

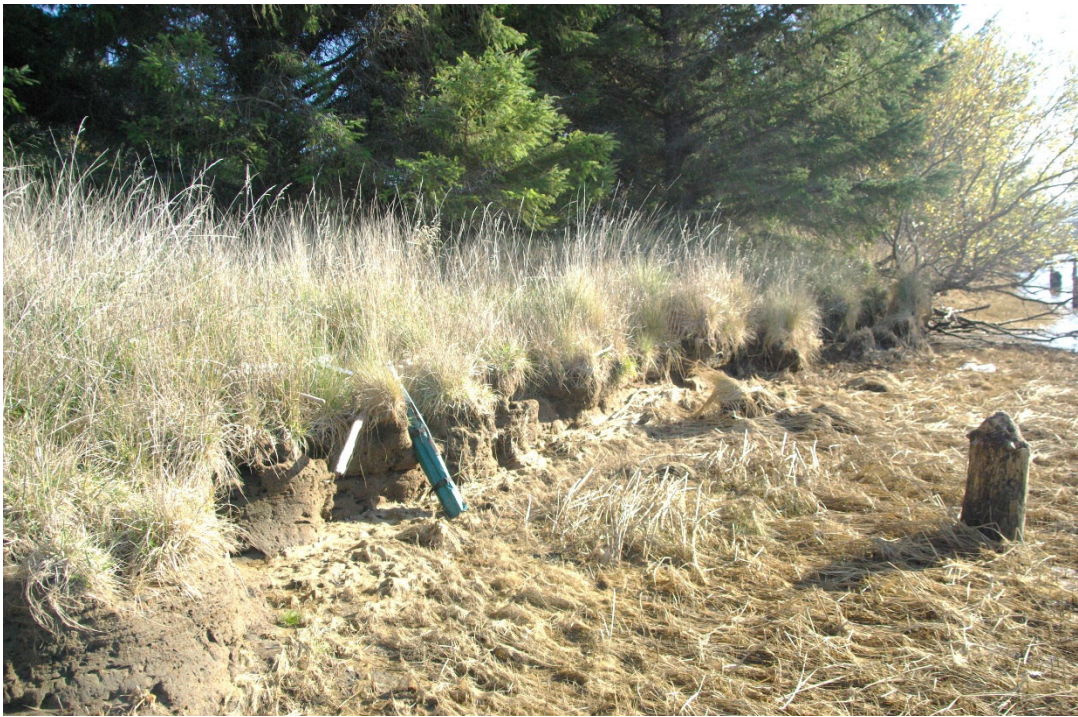
Photo B-12

Station	Conditions/Notes	Soil Exposed / Laboratory Results	Face Height	Photo
T-16	Erosion decreases.	Fine sandy silt fill over clayey silt. Interpret as fill over native soils.	3'	B-12
T-17	As T-15 but with higher bank		6 – 7'	B-13
