Pali Consulting

MEMORANDUM

Limited Geotechnical Evaluation
North Bank Working Landscapes Project
Coos County, Oregon
Pali Consulting Project #014-18-001

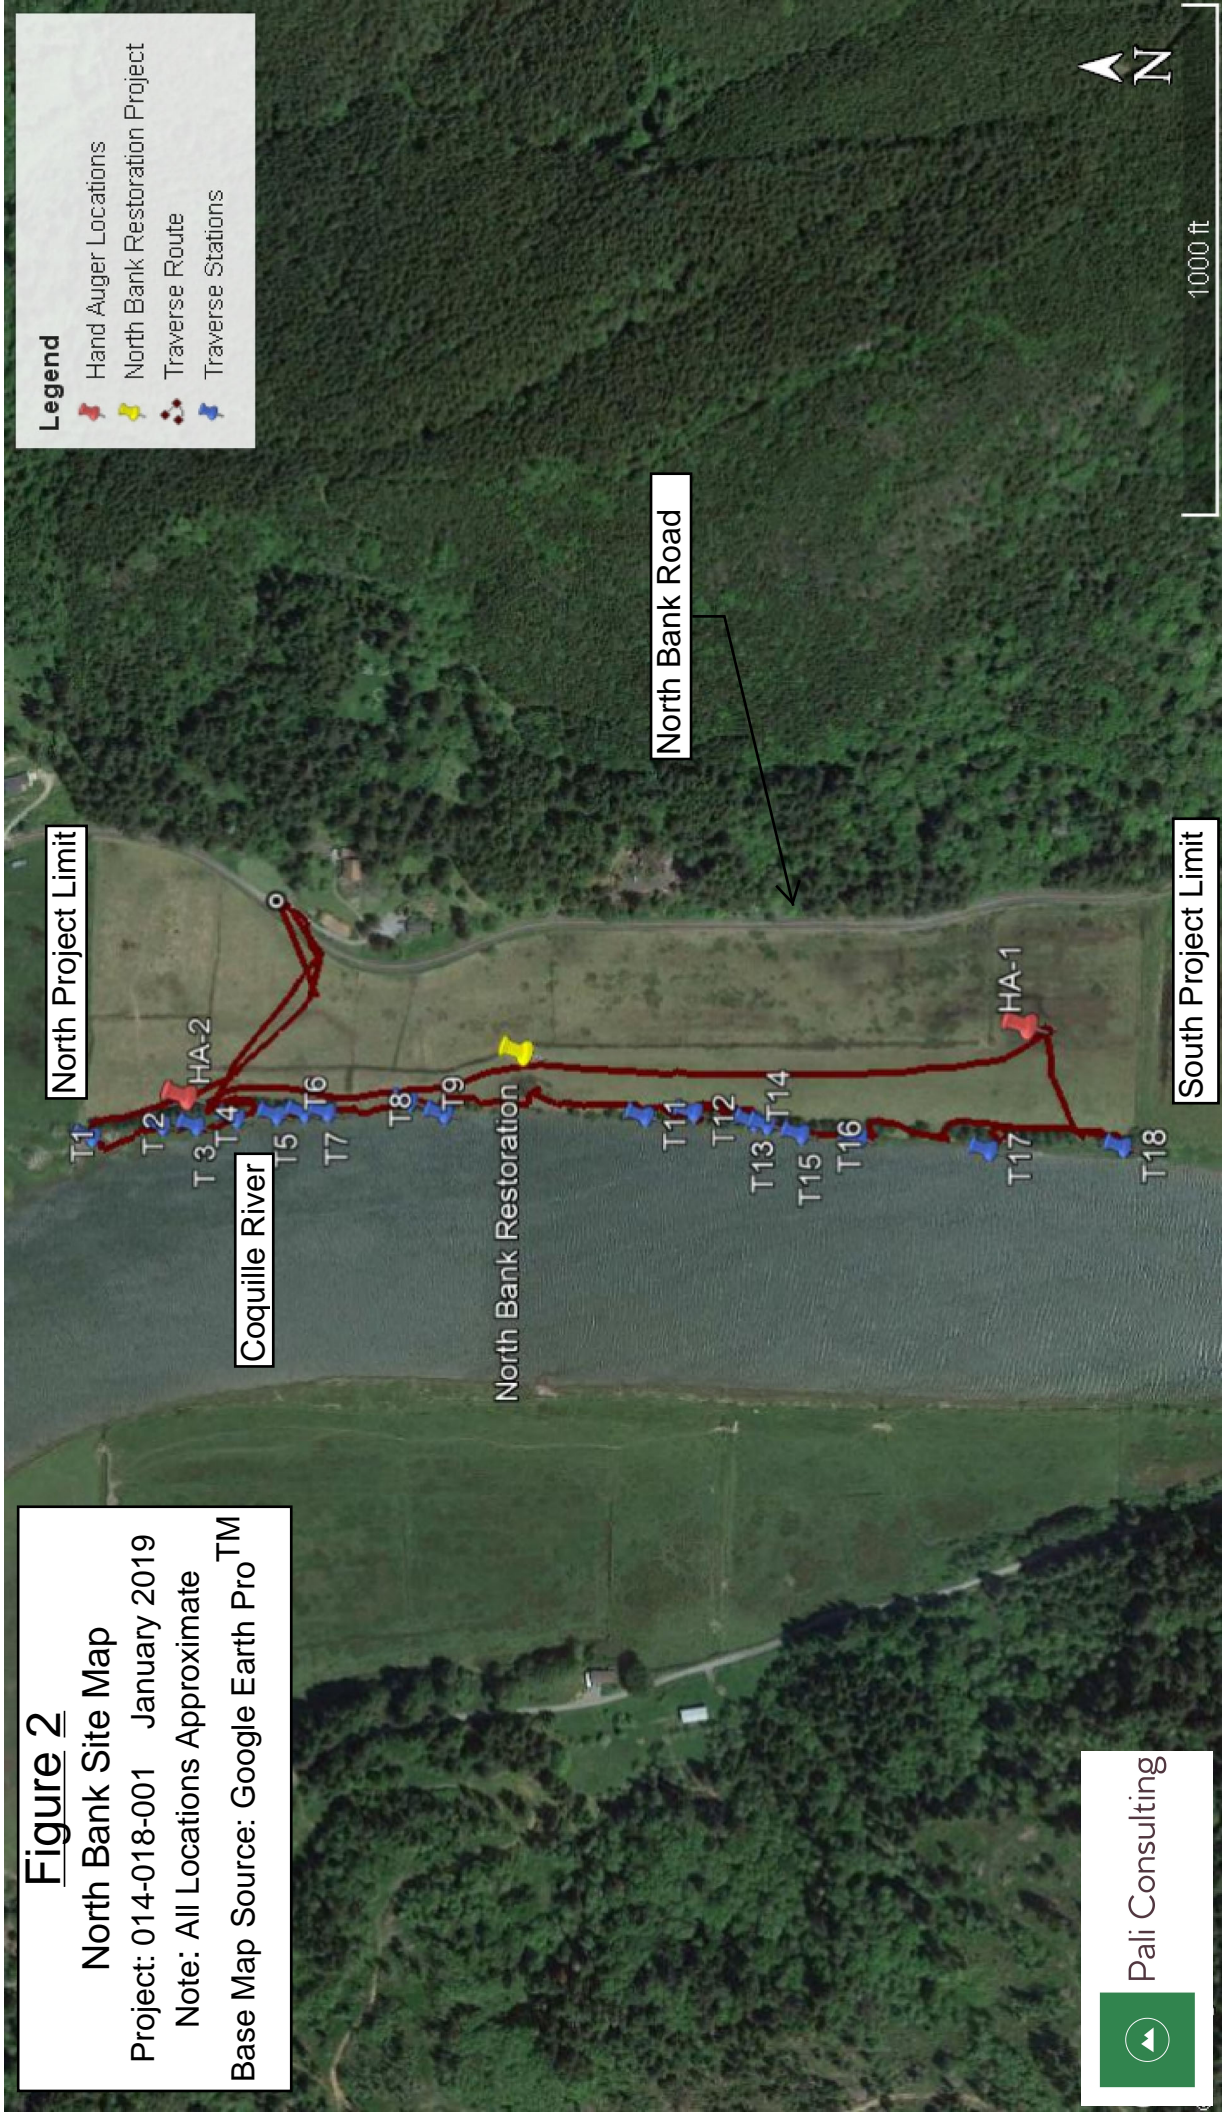
Figure 2
North Bank Site Map
Project: 014-018-001 January 2019
Note: All Locations Approximate
Base Map Source: Google Earth Pro™

We completed a detailed reconnaissance and documented physical features along the levee. Specific locations where we collected information are noted on Figure 2. A summary of observations at these stations, along with laboratory test results and site photographs at representative locations are included in Table 1 below.

We completed two hand auger borings at the locations shown on Figure 2. Laboratory testing was conducted on representative samples collected from the borings. A description of our subsurface exploration program and laboratory testing, and logs of the borings are included in Appendix A. The soils we encountered are described in detail below.
