# NOBLE CREEK TIDELANDS RESTORATION PROJECT

## EXISTING CONDITIONS, ALTERNATIVES, AND 60% BASIS OF DESIGN REPORT

*prepared for*  
Coos Soil and Water Conservation District

**WATERWAYS**  
CONSULTING, INC.

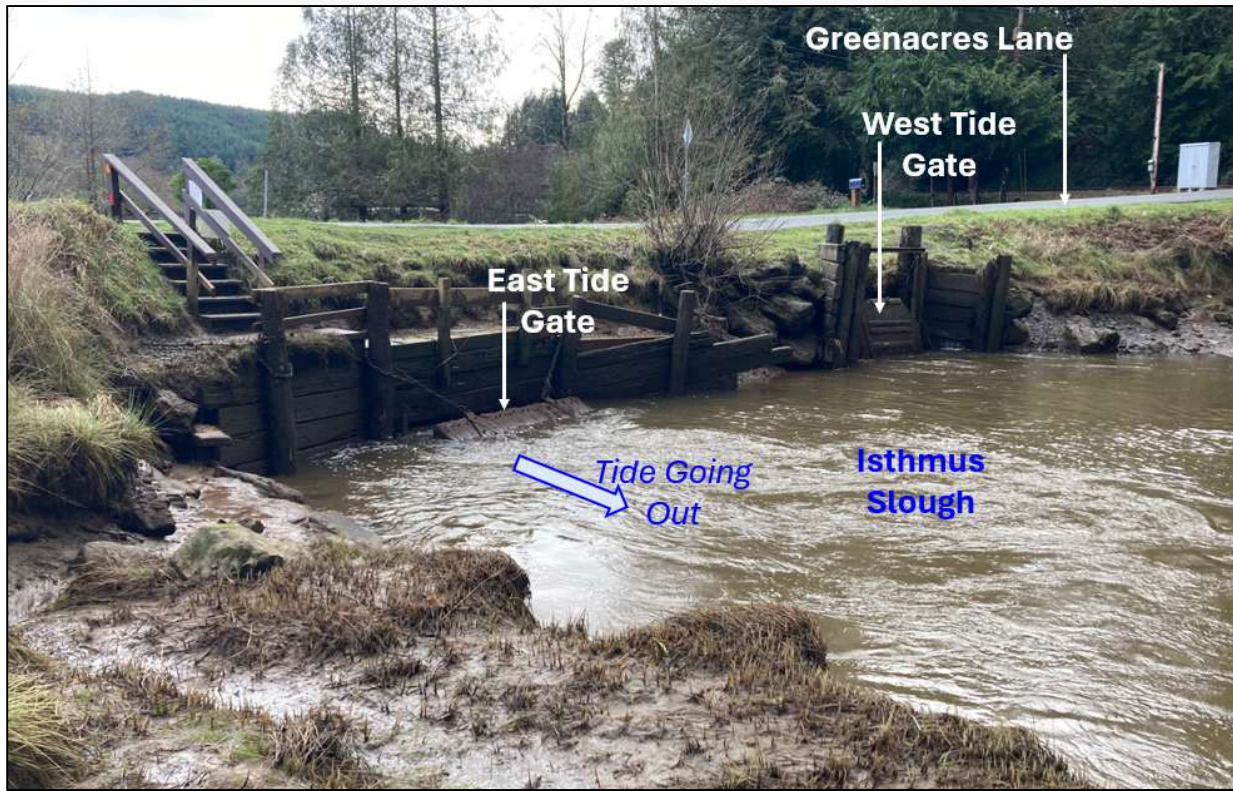
**Figure 4.** Photo Looking Upstream (South) at Greenacres Lane Crossing

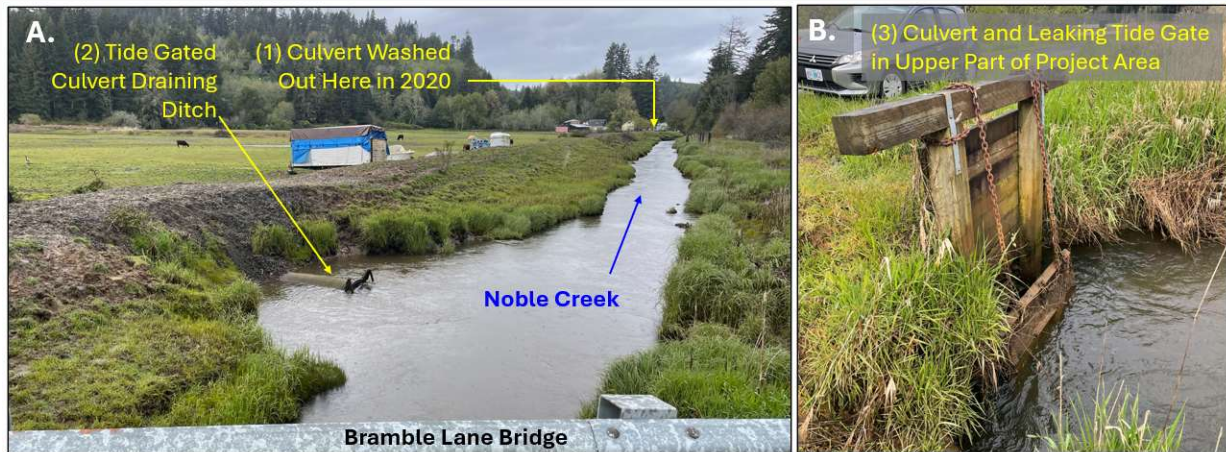
**Figure 23.** Photos of Current Locations Where Interior Culvert and Tide Gate Improvements are Proposed. (A) View Looking Downstream at Leveed Section of Noble Creek from Bramble Lane Bridge. (B) Photo of Tide Gate and Leaking Culvert in the Upper Part of Project Area

- (1) A new culvert would be installed in the levee on river left, several hundred feet upstream of GAL crossing (**Figure 23A**). This new culvert would be at the same location where a culvert washed out in May of 2020. Depending on the water management plan at the main GAL tide gates that stakeholders agree on, this interior culvert may or may not need a tide gate. If a tide gate is required, it would probably be equipped with a muted tidal regulator (MTR) that would allow fish passage into the Tidelands. This site would be a primary access point for fish into the floodplain and tidal channel network.

- (2) A culvert and tide gate on river left just downstream of the Bramble Lane Bridge over Noble Creek would be removed (**Figure 23A**). This is currently a leaking tide gated culvert that allows part of the existing ditch network to drain into Noble Creek. This feature will not be needed if the other culverts are upgraded, especially if the ditches are filled. The culvert would be removed and the levee section would be reconstructed.

- (3) An interior culvert and wooden tide gate in the upstream part of the project area would be replaced (**Figure 23B**). Leakage through this culvert currently allows some tidal exchange; however, the tidal signal is muted and fish passage is limited to non-existent. The upgraded culvert and tide gate would be designed to allow more tidal exchange and fish passage into the southeastern part of the Noble Creek Tidelands.

The selected alternative includes: (1) installing one new interior culvert through the Noble Creek levee, (2) removing an existing culvert in the Noble Creek levee, and (3) upgrading one culvert and tide gate under Bramble Lane (**Figure 22** and **Figure 23**). The interior culverts have the following design criteria:
